THE BIG FLOOD: WILL IT HAPPEN AGAIN?

Final report

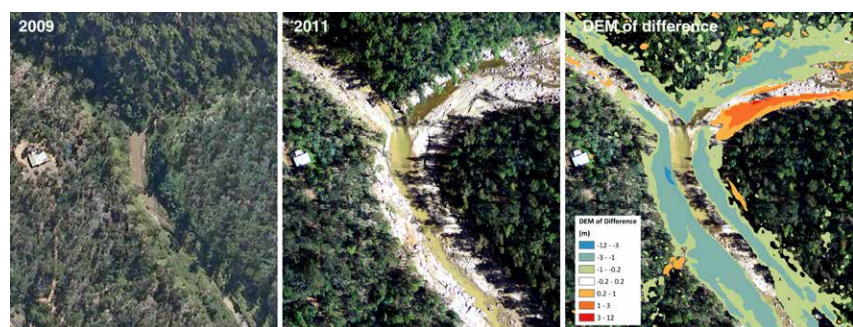
Figure 1. Pre-flood, post-flood and DEM of difference

Geomorphic change detection (GCD) using high resolution LiDAR digital elevation models from different time periods (pre- post-flood) was used to determine the extent and magnitude of change following a flood (Figure 1). The application used in the Lockyer was the largest scale this approach has been applied and gave very accurate estimates of erosion, deposition and sediment redistribution³.

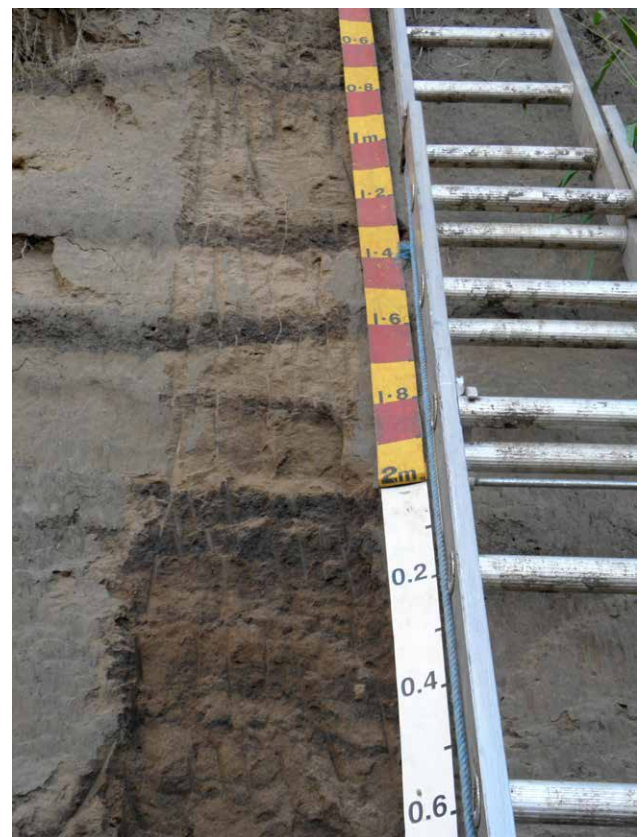
Figure 6. Flood unit sampling

These were located in the bank profiles exposed during the flood. They are horizontal and can range in thickness from 10cm to nearly 1m (Figure 6).

Sediments were taken in the field and taken back to the laboratory for dating using Optically Stimulated Luminescence (OSL) dating. OSL can measure the last time each grain of sand was exposed to sunlight, allowing us to determine a burial age for each flood unit. OSL is one of the most accurate ways to date the age of river sediment. A data base of over ~ 180 OSL ages have been compiled through this project ¹⁹.

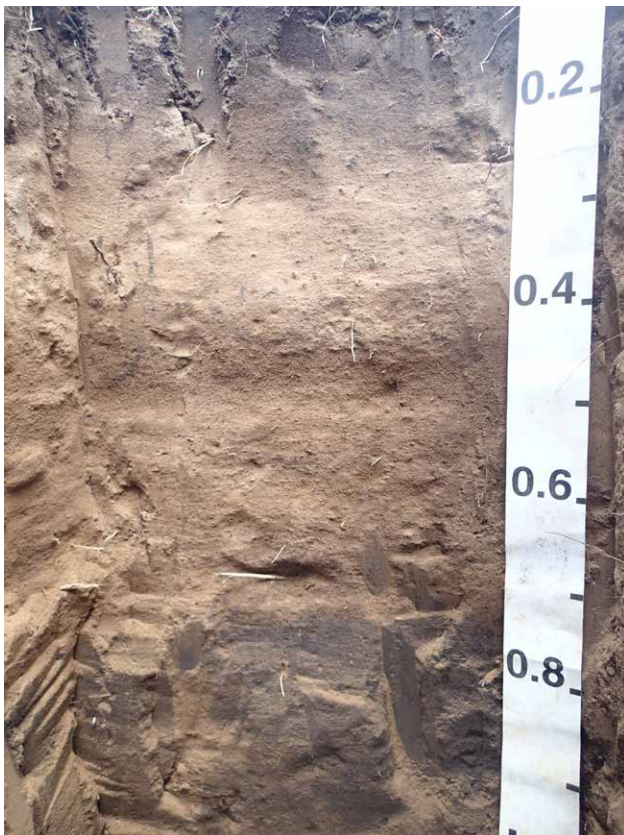
Figure 8. Slack water deposits

Slack-water deposits (Figure 7 and Figure 8) are flood-sediments deposited in slow flow or backwater zones generally on the margins of bedrock or laterally stable channels and are protected from subsequent erosion.

The timing of the flood is determined by OSL dating and the magnitude of the flood is reconstructed based on the minimum stage height of flow required to inundate the slack-water deposit. A calibrated hydraulic model is built based on topographic surveys and/or LiDAR DEMs and is used to estimate paleoflood magnitude.

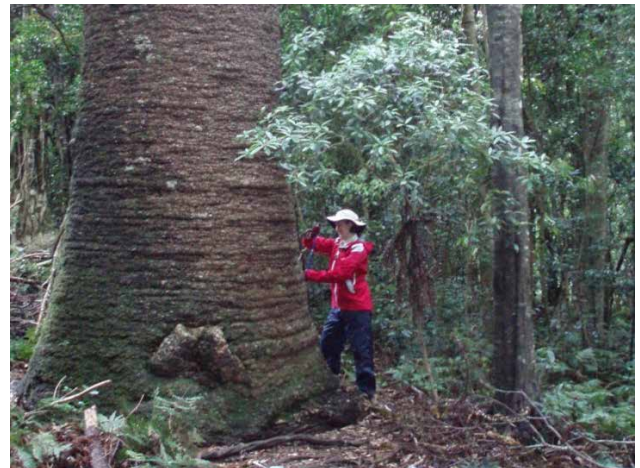
Figure 9. Tree rings can be assessed to reconstructed past rainfall patterns

One way of reconstructing past rainfall patterns is dendrochronology- the study of tree ring growth (Figure 9).

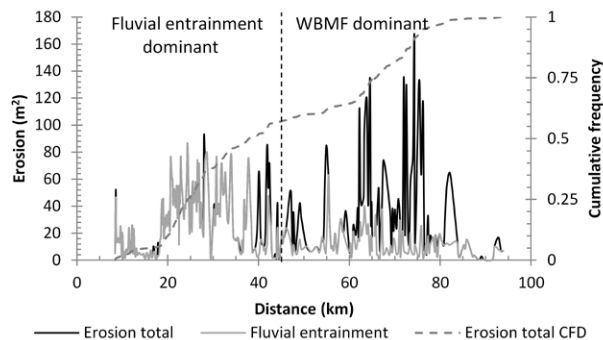
Figure 27. Wet-flow bank mass failure and fluvial entrainment down Lockyer Creek

The second process contributing to bank erosion during the 2011 event was Wet-flow Bank Mass Failures (WBMF) which was dominant along the lower Lockyer (Figure 27).

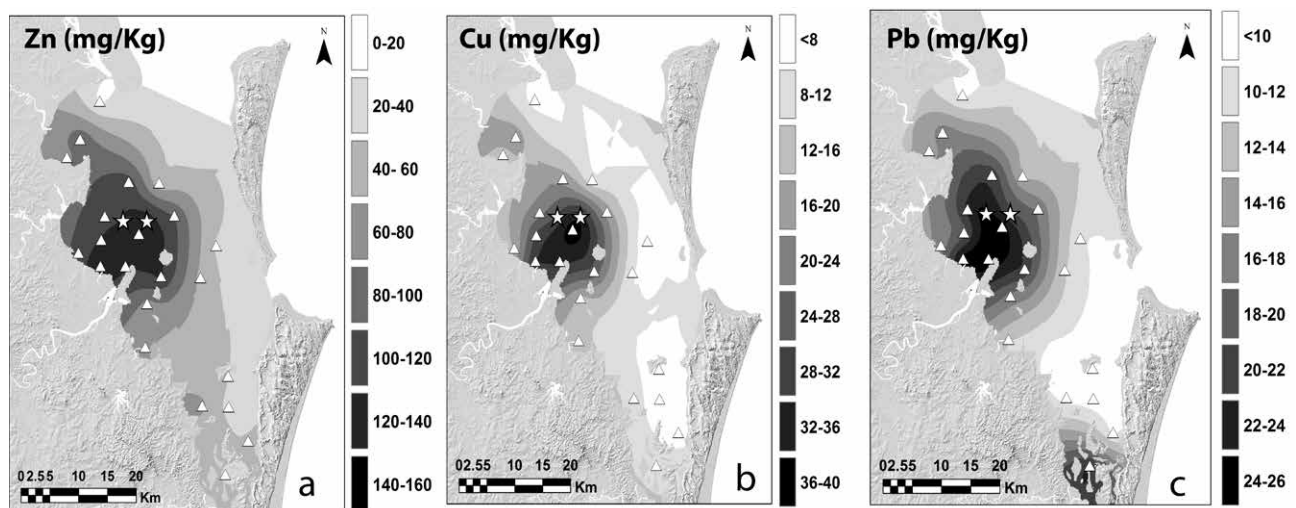
Figure 34. Distribution of heavy metals in Moreton Bay after the floods. From Coates-Marnane et al., 2016b

Shallow estuarine embayments receive contaminants from developed catchments. A significant increase in concentrations of Lead (Pb), Zinc (Zn) Copper (Cu) and other major elements were found in sediments in the Bay after the 2011 flood (Figure 34). These metal contaminants originate from a range of sources including urban impervious surfaces and industrial waste. Prior to the wet La Nina event from 2009-2012, the region was experiencing severe drought (the millennium drought). Low freshwater flows the decades prior to this intense wet period resulted in a build-up of metal contaminants in the drainage network, including the estuary. These contaminants were then rapidly delivered to the coast in a single flooding event. This highlights the importance of intermittent high magnitude floods in the subtropics in controlling contaminants export to coastal environments⁷.

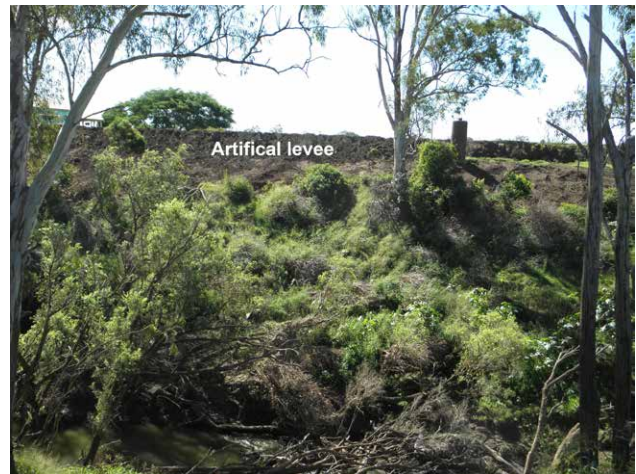
Figure 71. Artificial levee

Natural levees are a common feature along these laterally-stable channels in SEQ. Poorly planned and executed artificial levee construction (Figure 71) can limit floodplain deposition and significantly increase flow velocity, banktop discharges and associated stream powers, producing a higher likelihood of channel change such as channel avulsion (Figure 72). Research suggests that the lower Lockyer is at, or already exceeds, many of the recognised critical setup conditions for channel avulsion. In precautionary river management practice, such as those where 'erodible corridor' programs are becoming more popular, floodplain surfaces are allowed to inundate where possible and store sediment, thereby minimising the risk to life and property during extreme floods ³¹.
